Property Inspection Report

1 Main Street, Santa Rosa, CA 95401

Date of Inspection: 12/29/2017 Time: 9:00

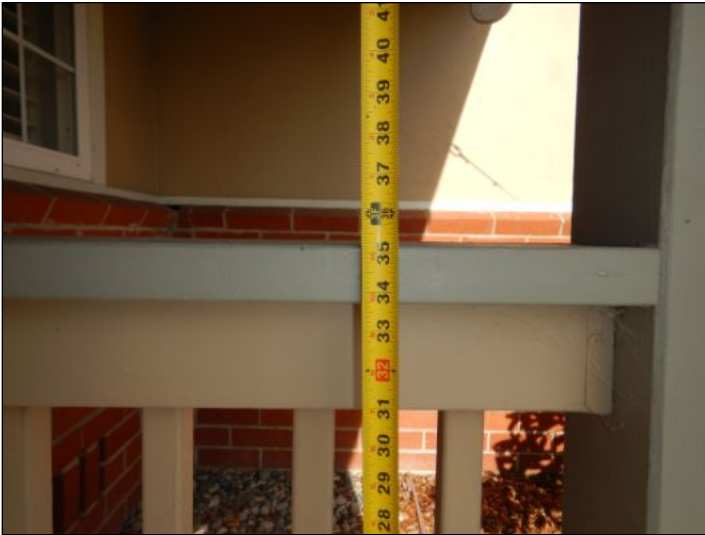
B.2. Railing height at the Front Porch of the Main House was below the current standard of 42 inches [2][5]

Railing height at the Front Porch of the Main House was below the current standard of 42 inches [2][5]

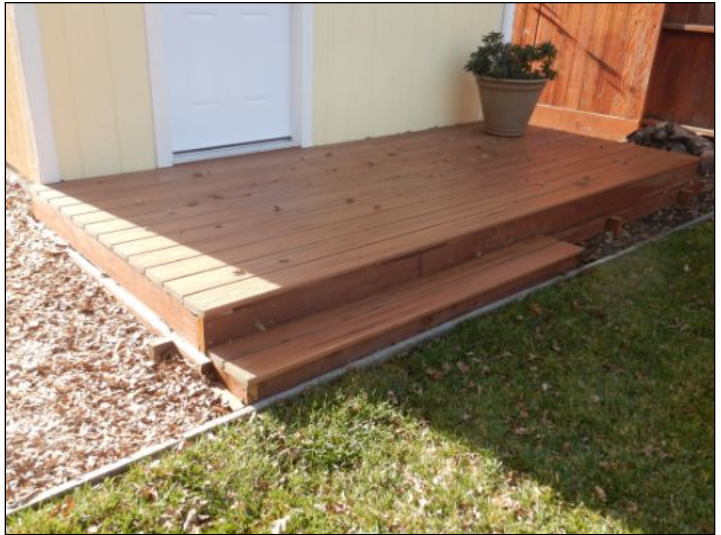
Unable to access the area below the Front Porch of the Art Studio, framing was not visible [1]

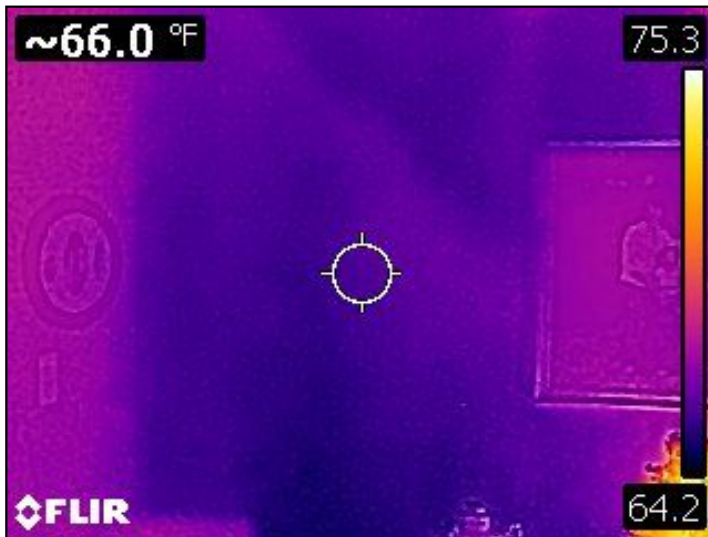
C.5. Infrared Scans showed signs of a lack of insulation in the Exterior Wall between the Front Room and the Garage, which was a common building practice at the time of construction. Recommend installing Exterior Wall insulation for improved energy efficiency. [2]

Infrared Scans showed signs of a lack of insulation in the Exterior Wall between the Front Room and the Garage [2]

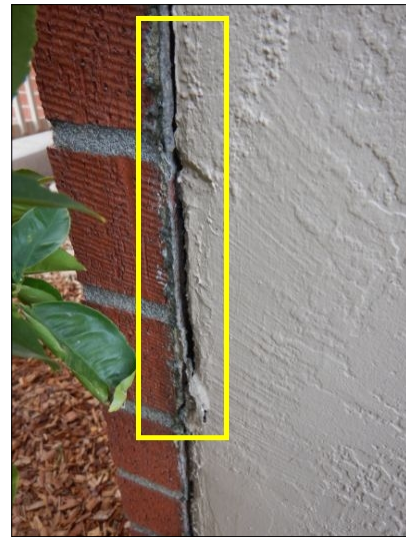
C.2. Gaps between the Siding and Brick Veneer needed filling to prevent moisture penetration and damage to wall assemblies [2]

Gaps between the Siding and Brick Veneer needed filling to prevent moisture penetration and damage to wall assemblies [2]

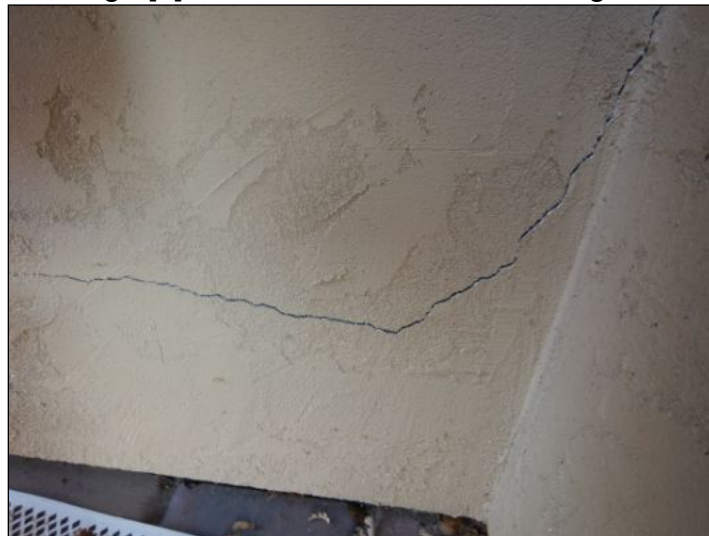
C.1. Cracks in the Stucco consistent with normal building settlement were noted at multiple locations; recommend sealing to prevent moisture penetration and damage to wall assemblies [2]

Cracks in the Stucco consistent with normal building settlement were noted at multiple locations [2]

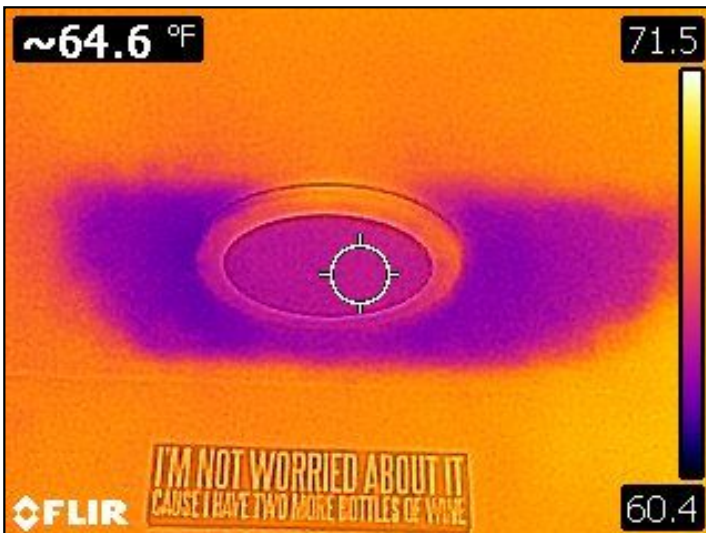
Infrared Scans showed signs of uneven distribution of the Attic insulation [2]

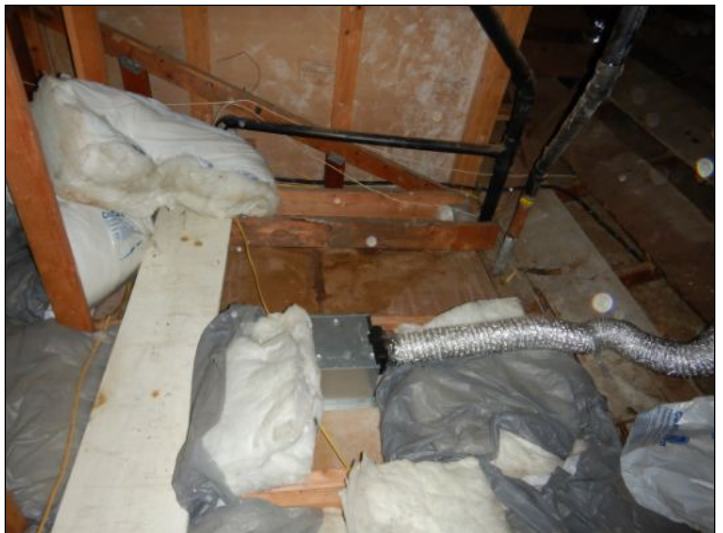
G.4. Gaps in the Insulation noted above the Half Bathroom [2]

Gaps in the Insulation noted above the Half Bathroom [2]

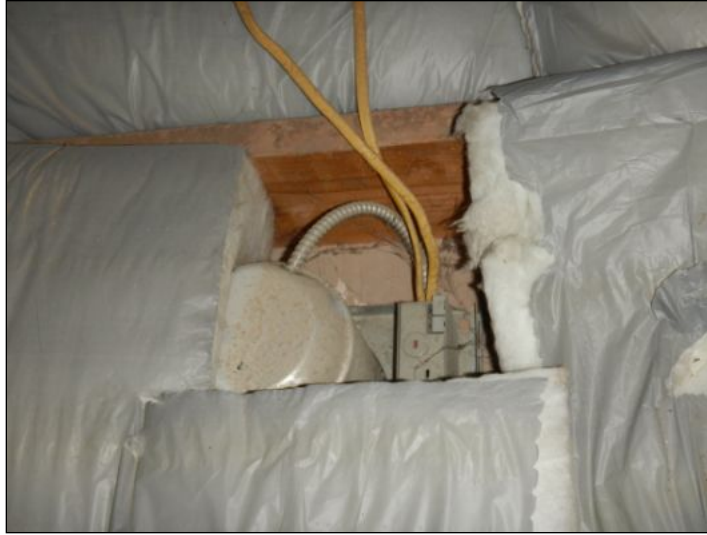
G.5. Gaps in the Insulation noted around the Recessed Lighting in the Family Room [2]

Gaps in the Insulation noted around the Recessed Lighting in the Family Room [2]

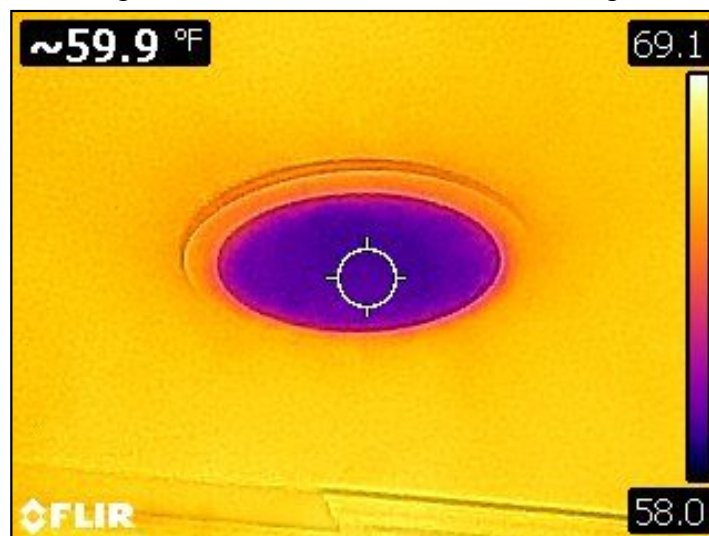
D.1. Infrared Scans showed a significant amount of heat loss through the installed Solar Tubes [2]

Infrared Scans showed a significant amount of heat loss through the installed Solar Tubes [2]

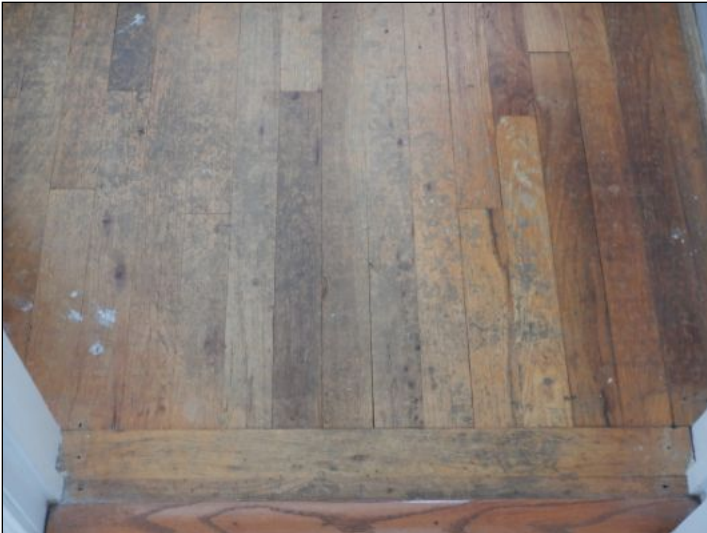
Wood Floor in the Master Bedroom needed resurfacing [2]

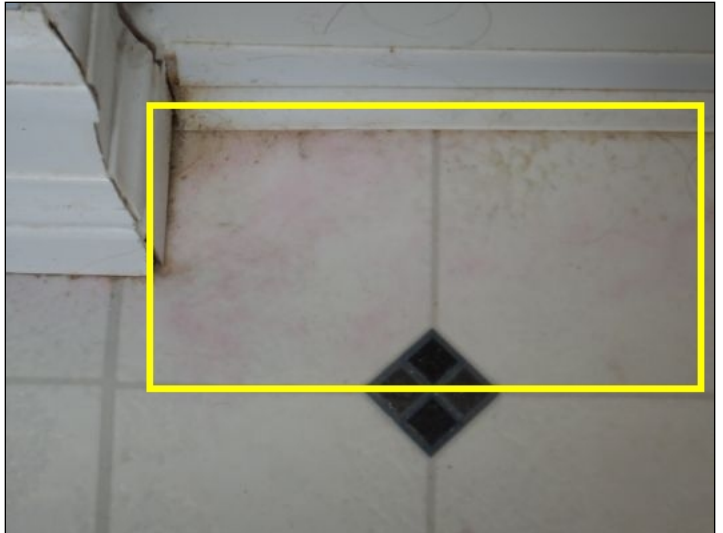
E.3. Discoloration of the Vinyl in the Master Bathroom is consistent with moisture being present under the Vinyl [2]

Discoloration of the Vinyl in the Master Bathroom is consistent with moisture being present under the Vinyl [2]

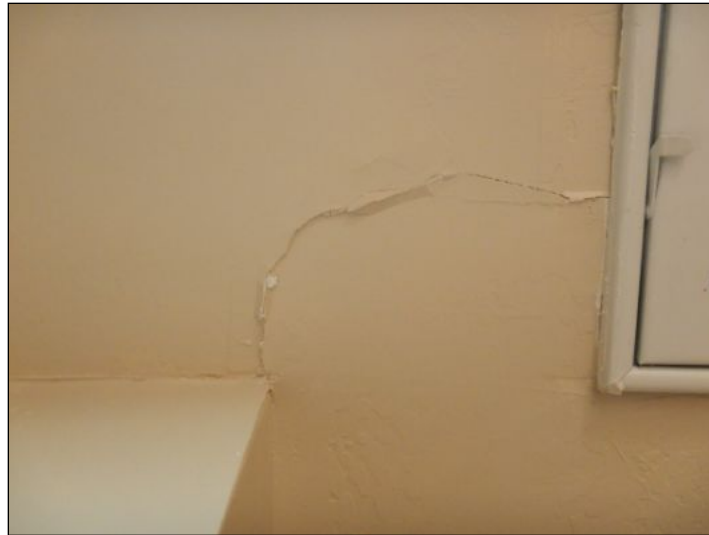
F.1. Common cracks consistent with normal building settlement were noted in the Ceiling. Cracks of the type noted are typically found at the drywall joints and could open and close seasonally due to movement of the soil below the home. [1]

Common cracks consistent with normal home settlement were noted in the Ceiling [1]

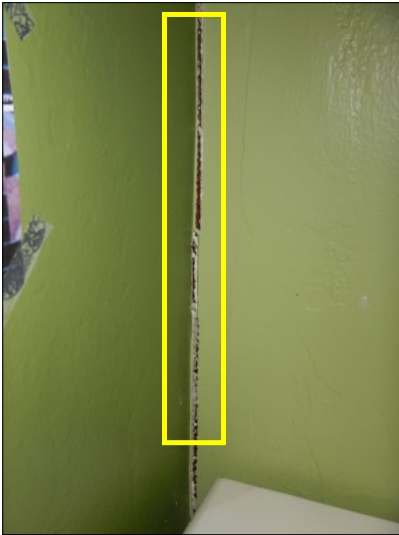
G.2. Common cracks in the Walls, consistent with normal building settlement, were noted. Cracks of the type noted are typically found at the drywall joints and around windows and doors. Cracks could open and close seasonally due to movement of the soil below the home. [1]

Common cracks in the Walls, consistent with normal home settlement, were noted [1]

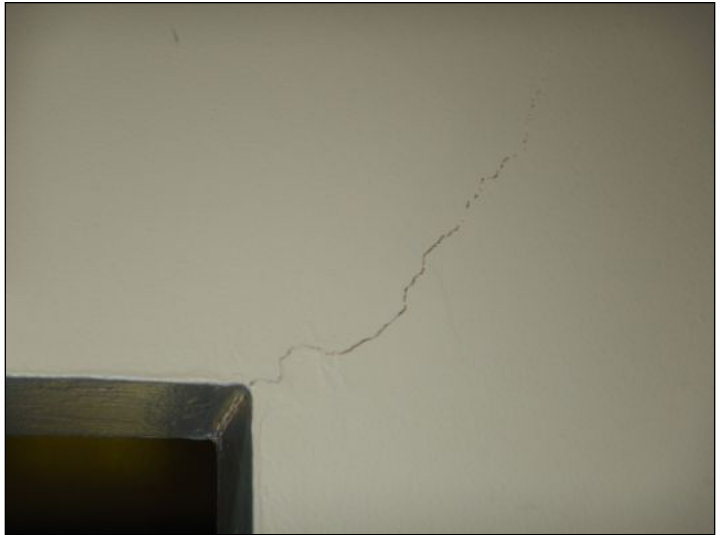
Common cracks in the Walls, consistent with normal home settlement, were noted [1]

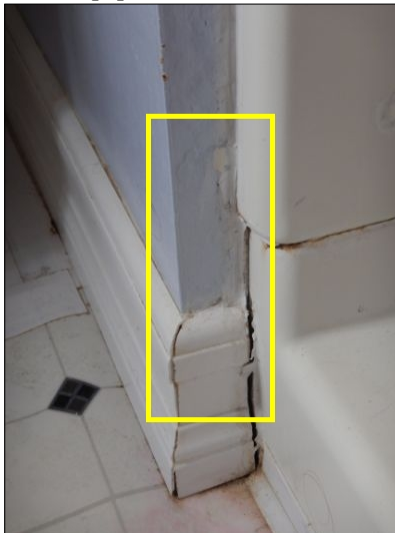
G.3. Wall at the Shower in the Master Bathroom had moisture damage; area appeared to be dry at the time of the inspection [2]

Wall at the Shower in the Master Bathroom had moisture damage; area appeared to be dry at the time of the inspection [2]

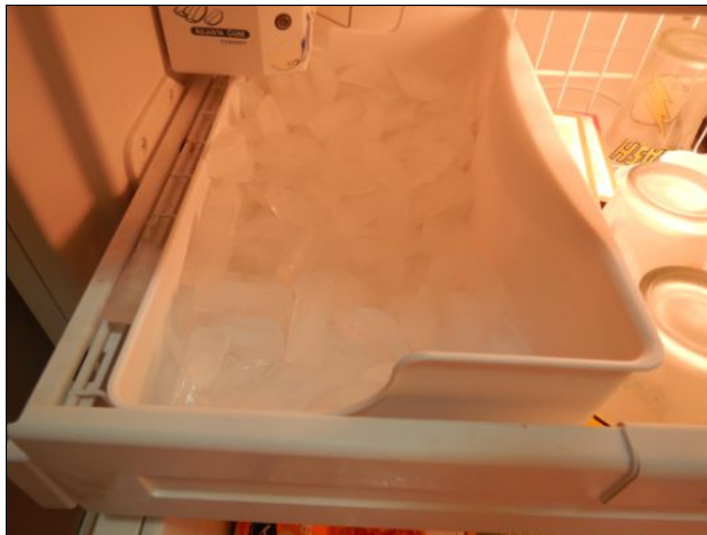
J.2. Ice Maker contained ice, but proper operation of the ice maker could not be verified

Ice Maker contained ice, but proper operation of the ice maker could not be verified

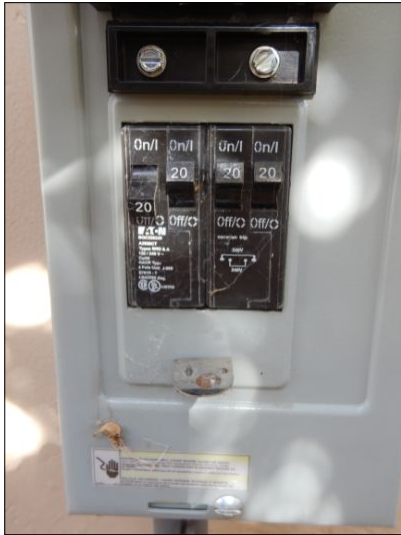
C.2. Breakers were not clearly labeled in the Electrical Sub Panel [5]

Breakers were not clearly labeled in the Electrical Sub Panel [5]

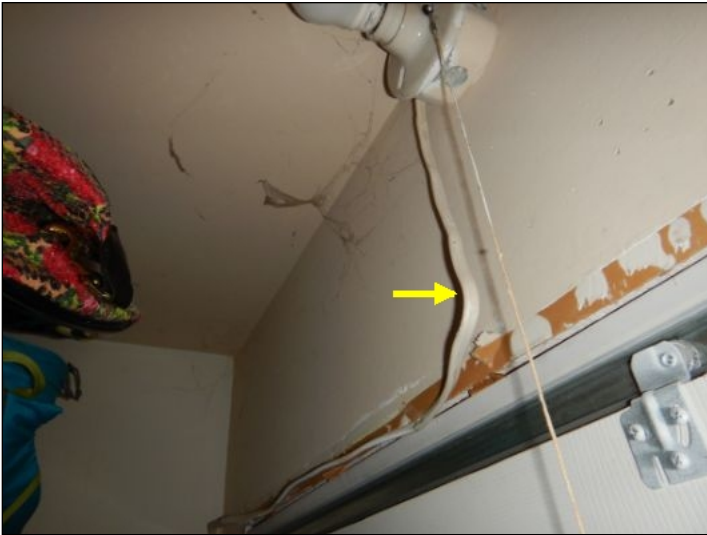
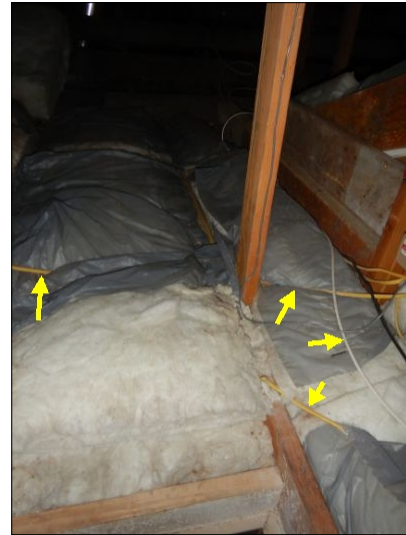
D.3. Unprotected wires were noted within 6 feet of the Attic Access [2][5]

Exposed wire in the Closet of the Master Bedroom below 8 feet and subject to damage [2][4] Unprotected wires were noted within 6 feet of the Attic Access [2][5]

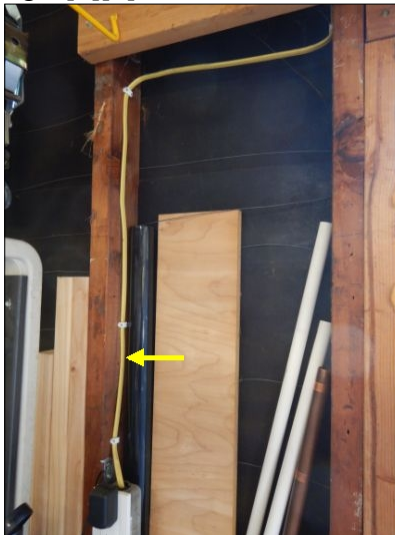
Exposed wires in the Garage were below 8 feet and subject to damage [2][4]

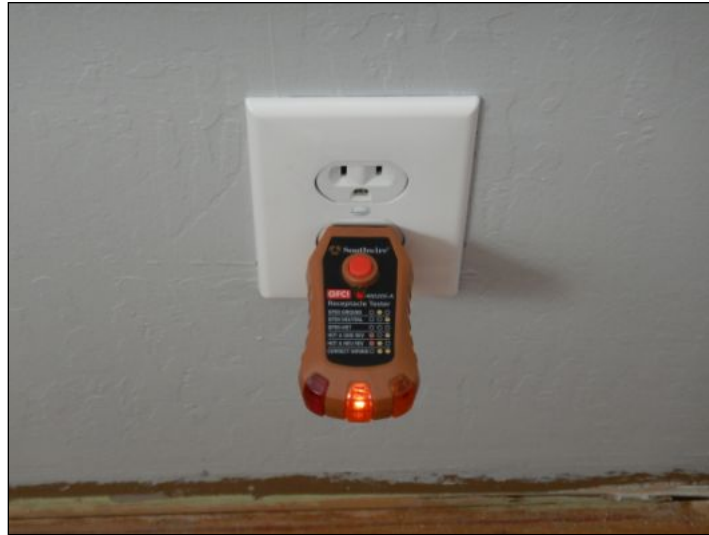
E.3. 3-slot receptacle tests indicated the lack of a proper Ground at multiple locations throughout the building. It is recommended that an Electrician either replace all of the improper 3-slot receptacles with the proper 2-slot type, or properly Ground all of the ungrounded receptacles. [2][5]

3-slot receptacle tests indicated the lack of a proper Ground at multiple locations throughout the building [2][5]

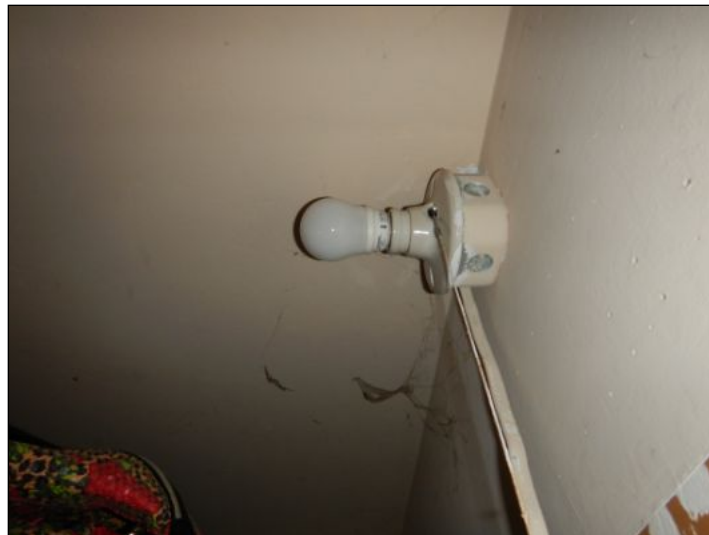
G.1. Exposed light bulb in the Closet of the Master Bedroom noted; recommend replacing with an enclosed fixture [4]

Exposed light bulb in the Closet of the Master Bedroom noted; recommend replacing with an enclosed fixture [4]

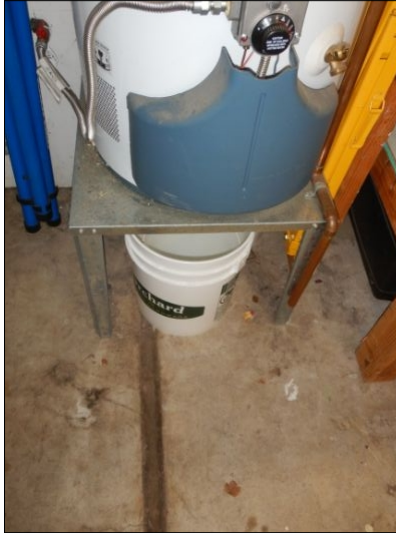
D.2. Recommend adding a Car Barrier, as per current building standards, to protect the Water Heater from possible damage [2][4]

Recommend adding a Car Barrier, as per current building standards, to protect the Water Heater from possible damage [2][4]

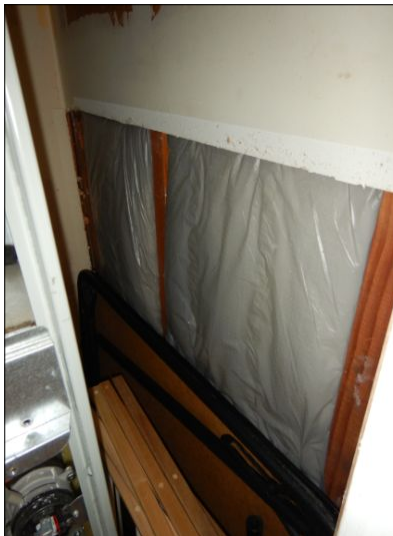
C.2. Enclosure Wall was missing Drywall [2]

Enclosure Wall was missing Drywall [2]

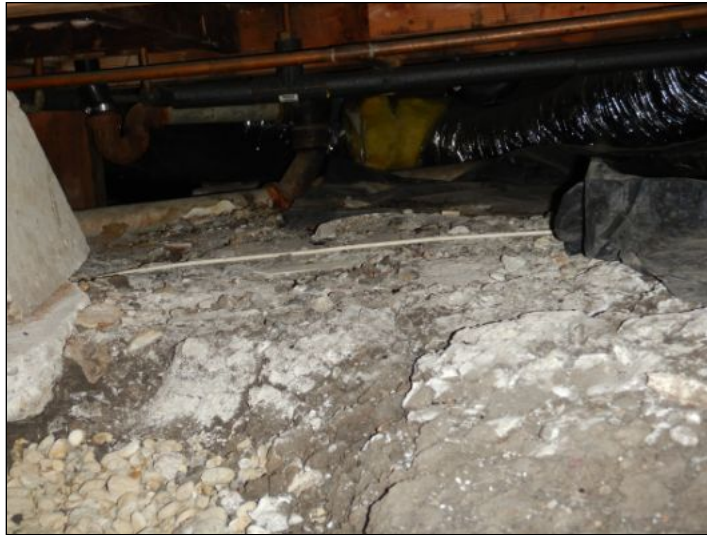
Vapor Barrier did not completely cover the Crawlspace below the originally constructed portion of the Home [2]

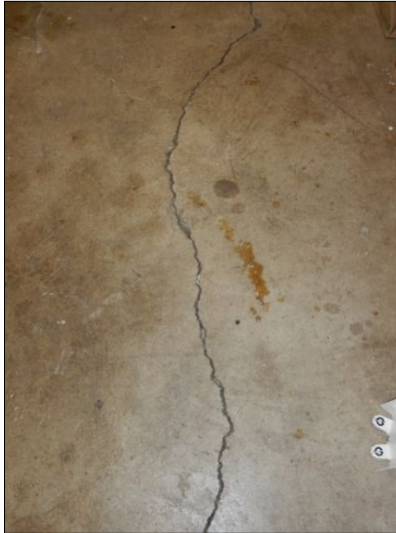
D.2. Moderate cracks and surface movement noted [2]

Moderate cracks and surface movement noted [2]

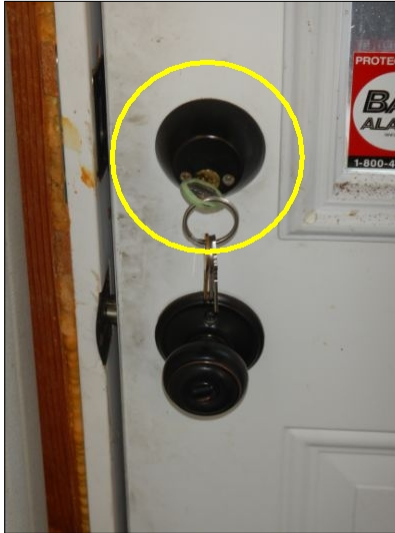
G.1. Garage Service Door had a dual keyed lock; all doors should have keyless operation from the interior in case of an emergency [2][5]

Garage Service Door had a dual keyed lock [2][5]
