Property Inspection Report

1 Main Street, Santa Rosa, CA 95401

Date of Inspection: 1/1/2020 Time: 9:00

Inspector: Julian Benton

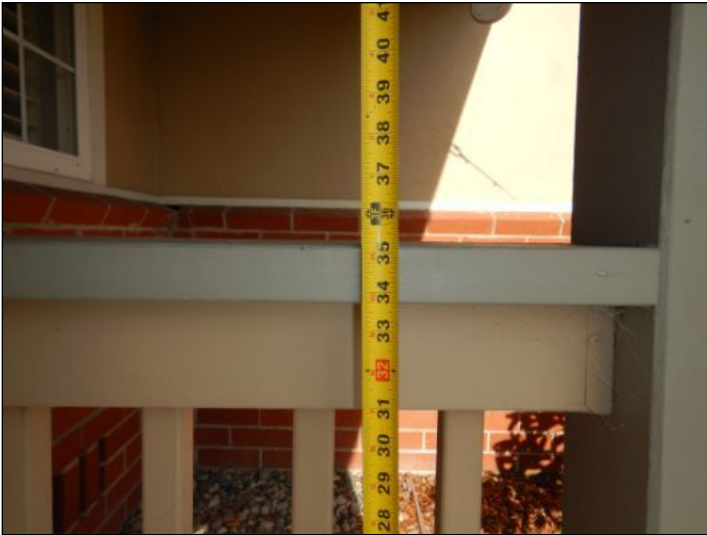
Railing height at the Front Porch was below the current building standard of 42 inches; walking surface was less than 16 inches above the ground [2][4]

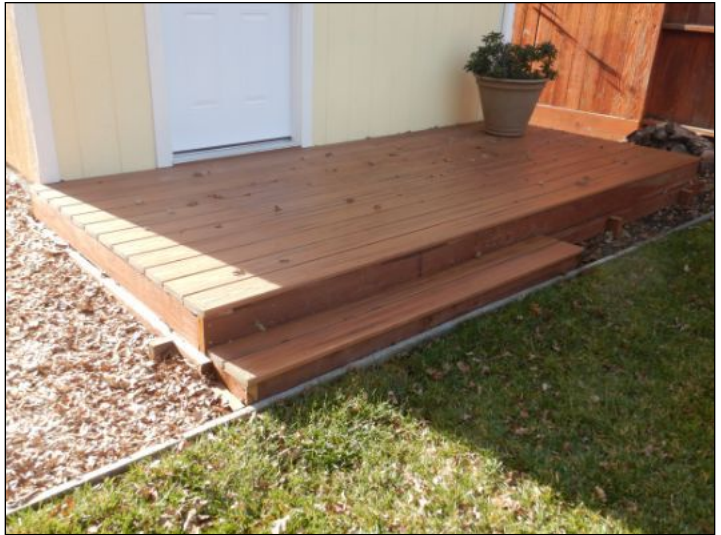
B.3. Unable to access the area below the Front Porch of the Craft Room, framing was not visible [1]

Unable to access the area below the Front Porch of the Craft Room, framing was not visible [1]

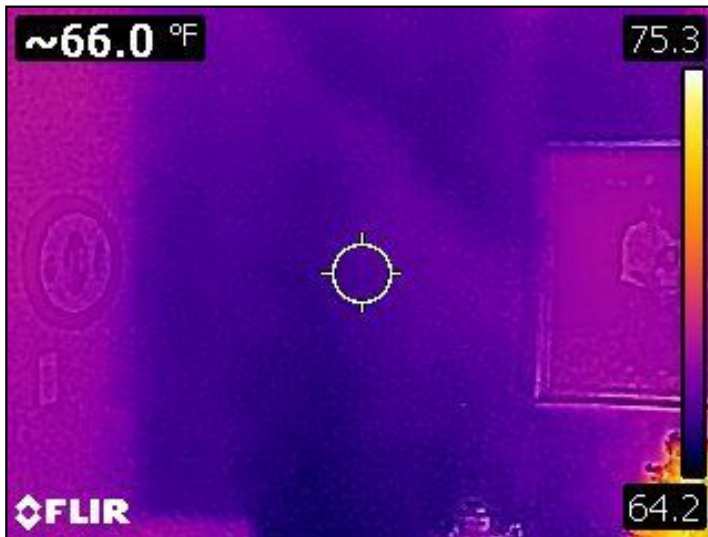
C.4. Infrared Scans showed signs of a lack of insulation in the Exterior Wall between the Front Room and the Garage, which was a common building practice at the time of construction. Recommend installing Exterior Wall insulation for improved energy efficiency. [2]

Infrared Scans showed a lack of insulation in the Exterior Walls [2]

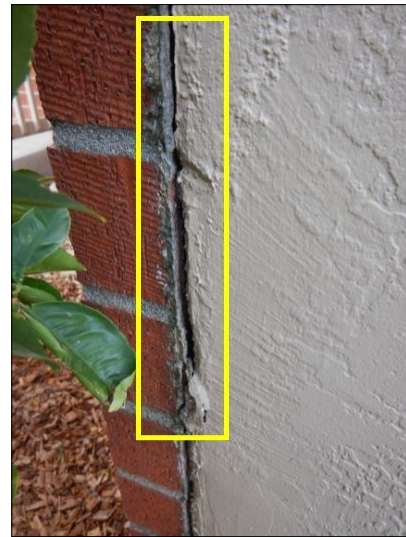
C.5. Gaps between the Siding and Brick Veneer needed filling to prevent moisture penetration and damage to wall assemblies [2]

Gaps between the Siding and Brick Veneer needed filling to prevent moisture penetration and damage to wall assemblies [2]

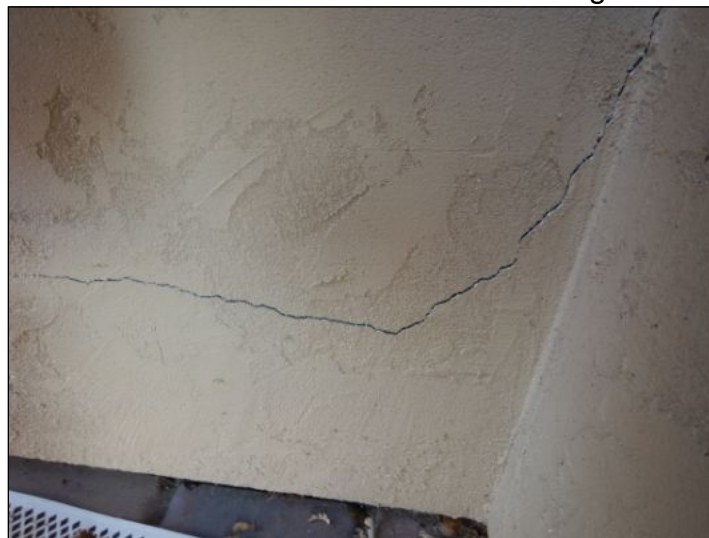
C.2. Cracks in the Stucco consistent with normal building settlement were noted at multiple locations; recommend sealing to prevent moisture penetration and damage to wall assemblies [2]

Cracks in the Stucco consistent with normal building settlement were noted at multiple locations; recommend sealing to prevent moisture penetration and damage to wall assemblies [2]

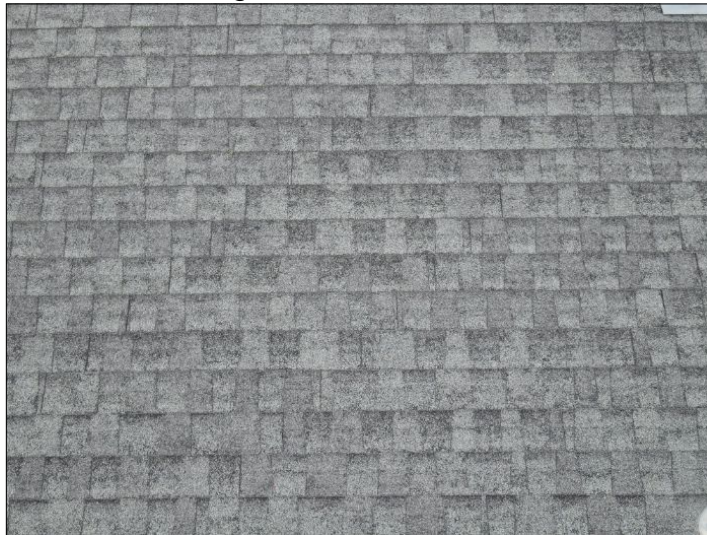
A.2. Granule loss on the Roof Surface was typical to what would be found with an older Roof [1]

Granule loss on the Roof Surface was typical to what would be found with an older Roof [1]

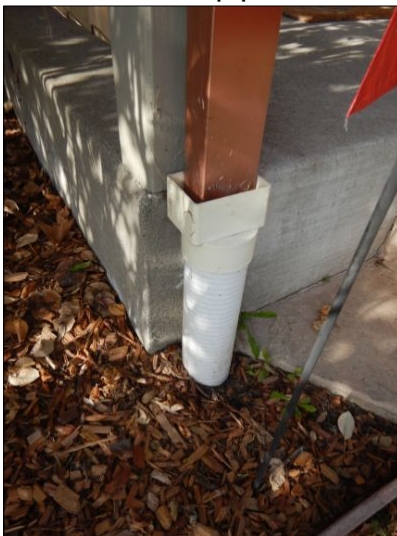
C.2. Condition and effectiveness Subsurface Drainpipes could not be determined

Condition and effectiveness Subsurface Drainpipes could not be determined

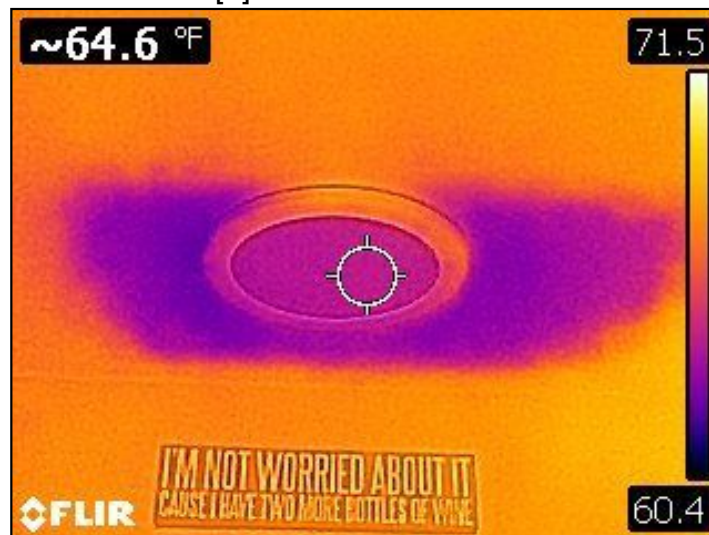
G.3. Infrared Scans showed signs of uneven distribution of the insulation which reduces the effective R-value of the Attic Insulation [2]

Infrared Scans showed signs of uneven distribution of the insulation which reduces the effective R-value of the Attic Insulation [2]

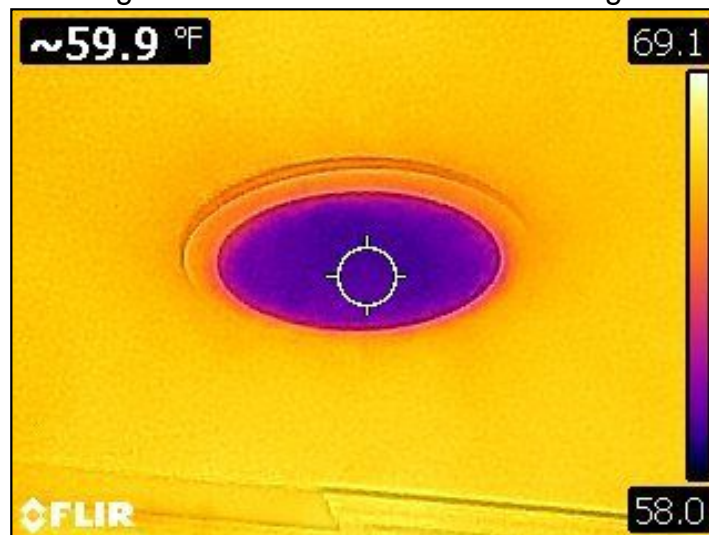
D.2. Infrared Scans showed a significant amount of heat loss through the installed Solar Tubes [2]

Infrared Scans showed a significant amount of heat loss through the installed Solar Tubes [2]

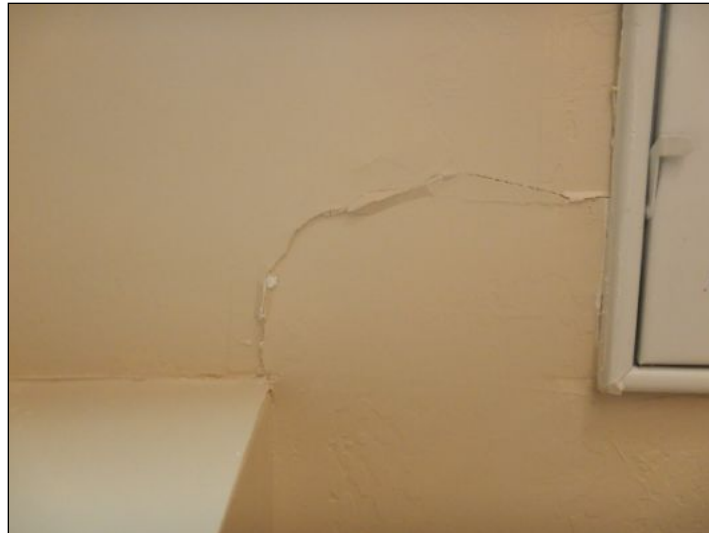
E.2. Common cracks consistent with normal foundation settlement were noted in the Ceiling of the Main House. Cracks of the type noted are typically found at the drywall joints and could open and close seasonally due to movement of the soil below the building. [1]

Common cracks consistent with normal home settlement were noted in the Ceiling [1]

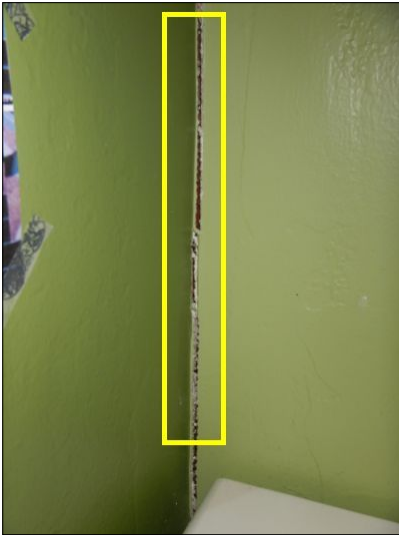
G.3. Common cracks in the Walls, consistent with normal foundation settlement, were noted in the Main House. Cracks of the type noted are typically found at the drywall joints and around windows and doors. Cracks could open and close seasonally due to movement of the soil below the building. [1]

Common cracks in the Walls, consistent with normal building settlement, were noted [1]

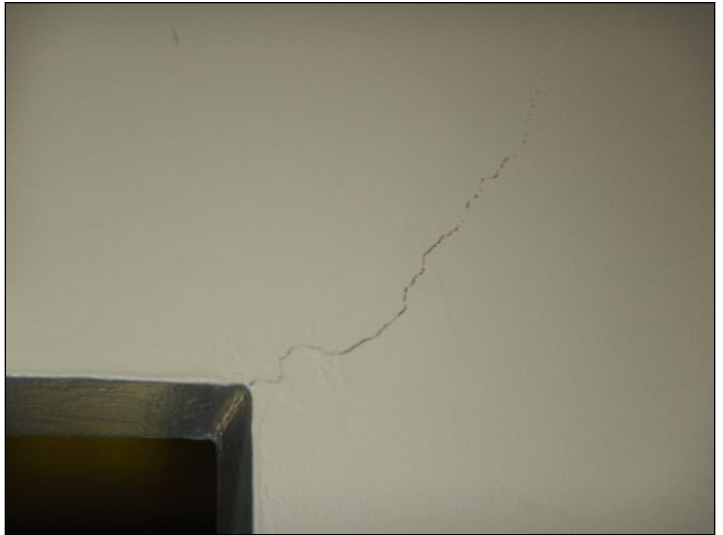
Common cracks in the Walls, consistent with normal building settlement, were noted [1]

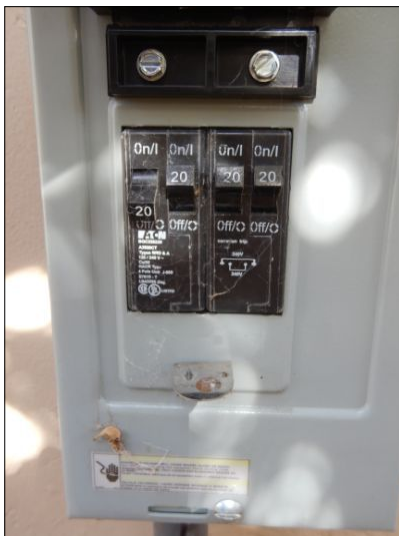
C.3. Breakers were not clearly labeled in the Electrical Sub Panel [5]

Breakers were not clearly labeled in the Electrical Sub Panel [5]

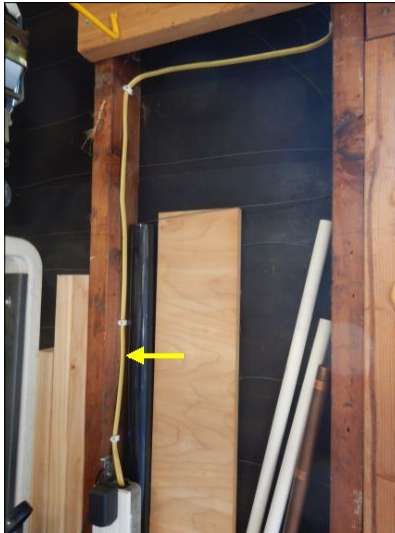
D.2. Exposed wires in the Garage were below 8 feet and subject to damage; recommend either covering the areas with drywall or putting the wires in conduit [2][4]

Exposed wires in the Garage were below 8 feet and subject to damage [2][4]

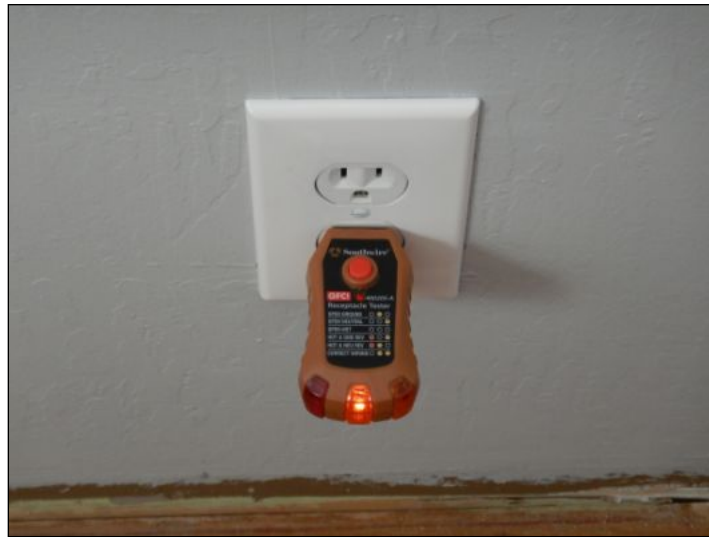
E.3. 3-slot receptacle tests indicated the lack of a proper Ground at multiple locations throughout the Home. It is recommended that an Electrician either replace all of the improper 3-slot receptacles with the proper 2-slot type, or properly Ground all of the ungrounded receptacles. [2][5]

3-slot receptacle tests indicated the lack of a proper Ground at multiple locations throughout the building [2][5]

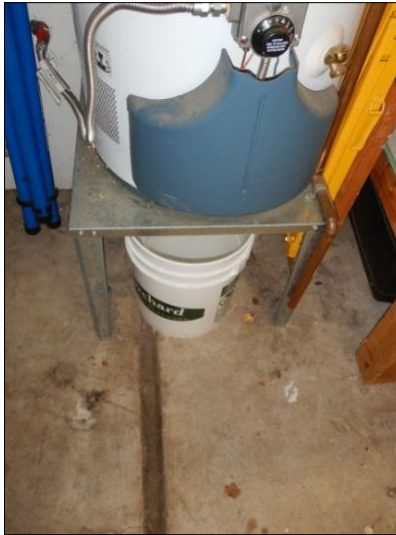
Recommend installing a Drain Pan with a pipe that extends to the exterior [2]

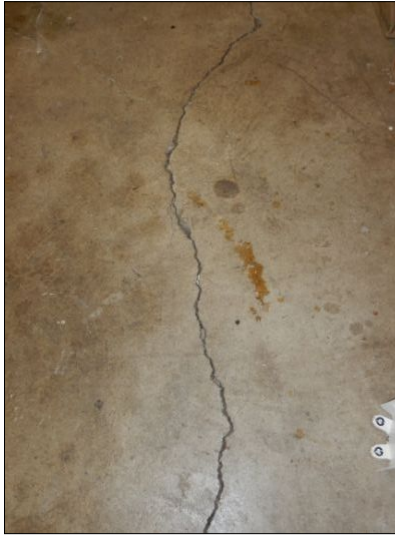
D.3. Moderate cracks and surface movement noted [2]

Moderate cracks and surface movement noted [2]

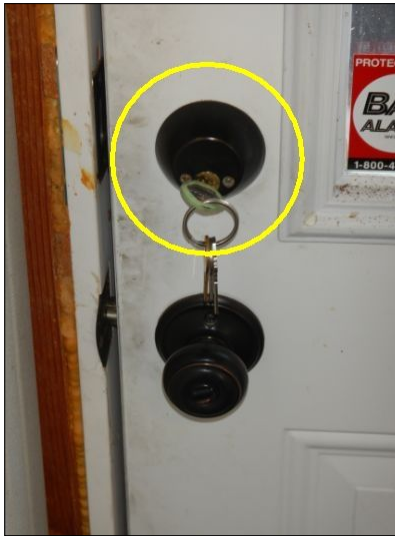
G.2. Garage Service Door had a dual keyed lock; all doors should have keyless operation from the interior in case of an emergency [2][5]

Garage Service Door had a dual keyed lock; all doors should have keyless operation from the interior in case of an emergency [2][5]
